Civil Service Sailing Association - Channel Sailing Division

SKIPPERS NOTES – Yacht Sea Essay of Hamble

Newsletter No 02/15

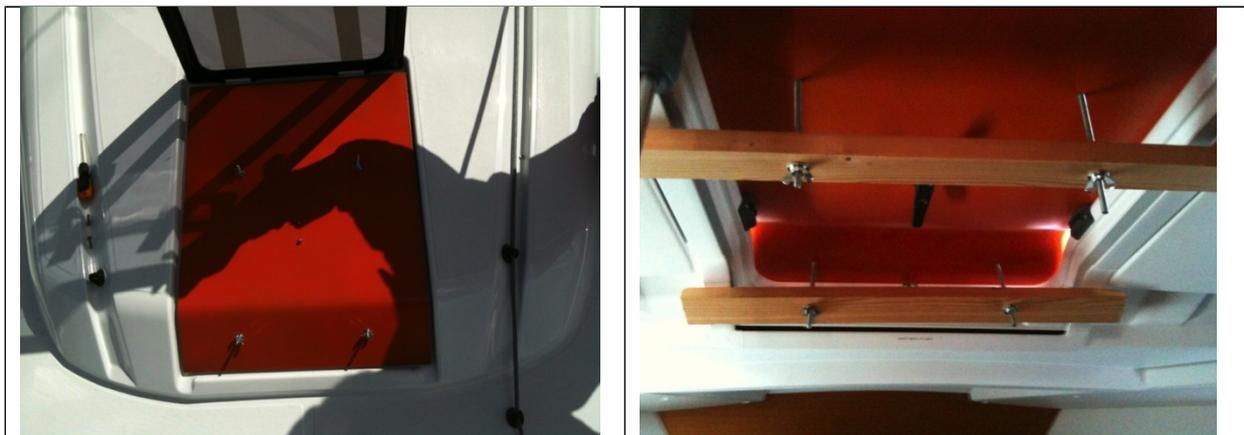
Under the MCA code for commercial pleasure vessels fore hatches are required to be hinged at their forward ends. Thus if the hatch catches fail, or if it has been left open, seas breaking over the bow will tend to force the hatch closed – a fail-safe design. The new Sea Essay however has a fore hatch, which is hinged at its aft end and consequently opens like crocodile jaws. If this is left open during heavy weather there is a possibility that the fore hatch could be ripped off its hinges allowing water to cascade into the forecabin and swamp the boat. The MCA code therefore requires vessels with aft hinged fore hatches to carry a fore hatch blanking plate. Sea Essay now has one. It is a 510mm x 680mm x 5mm shaped aluminium plate which fits the fore hatch opening by means of two wooden battens and four screwed rods with eight wing nuts. The photographs below show how it is fitted. It can be fitted from inside the forecabin and is to be used when the fore hatch itself has been ripped off or is somehow missing or is unserviceable. The blanking plate is stored in an orange bag in the underfloor compartment of the main cabin, which also houses the storm jib. Instructions for installing the blanking plate are in the bag.

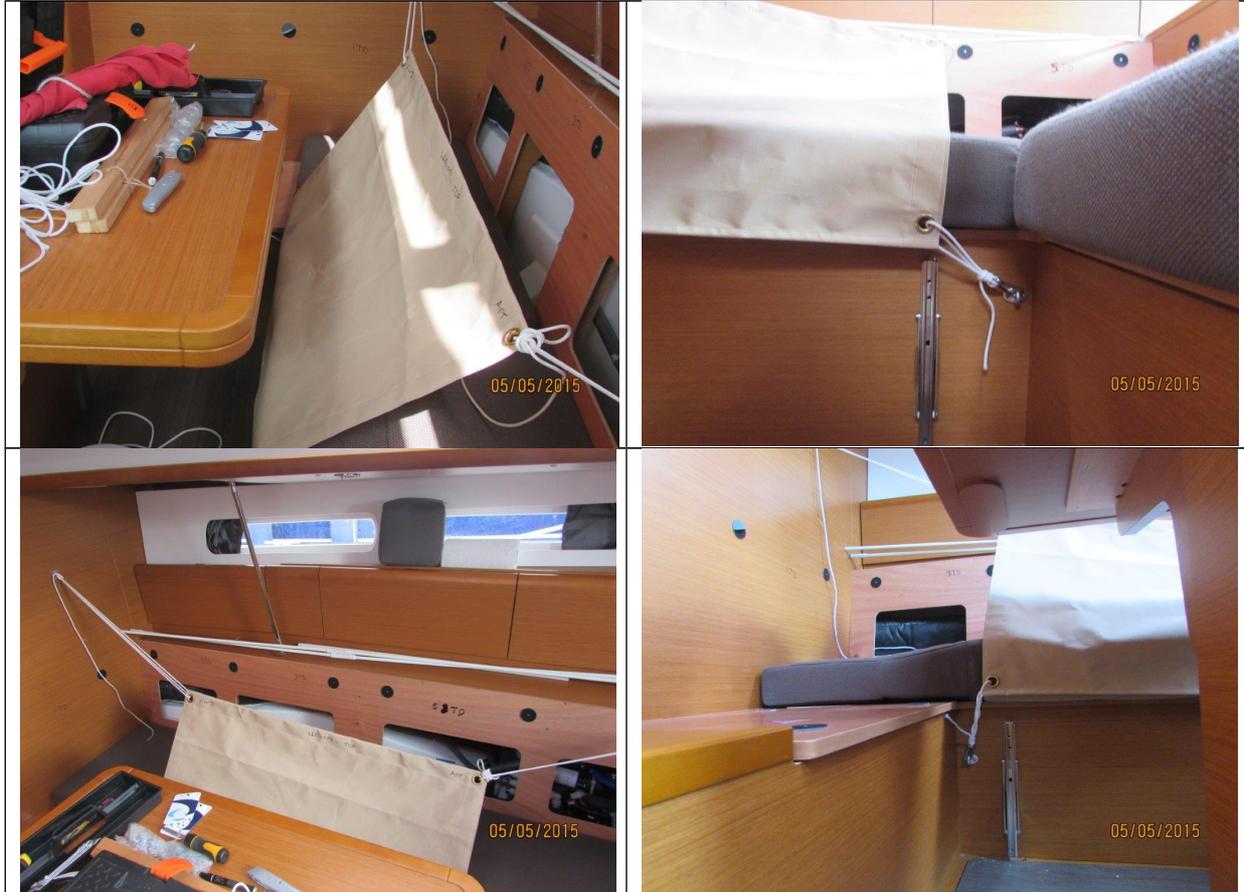
Skippers should note that the arrangements for setting up the lee cloth have been modified as the fixing rings on the locker lids were damaging the seat cushions. The new locations of the fixing rings are shown in the photographs below.

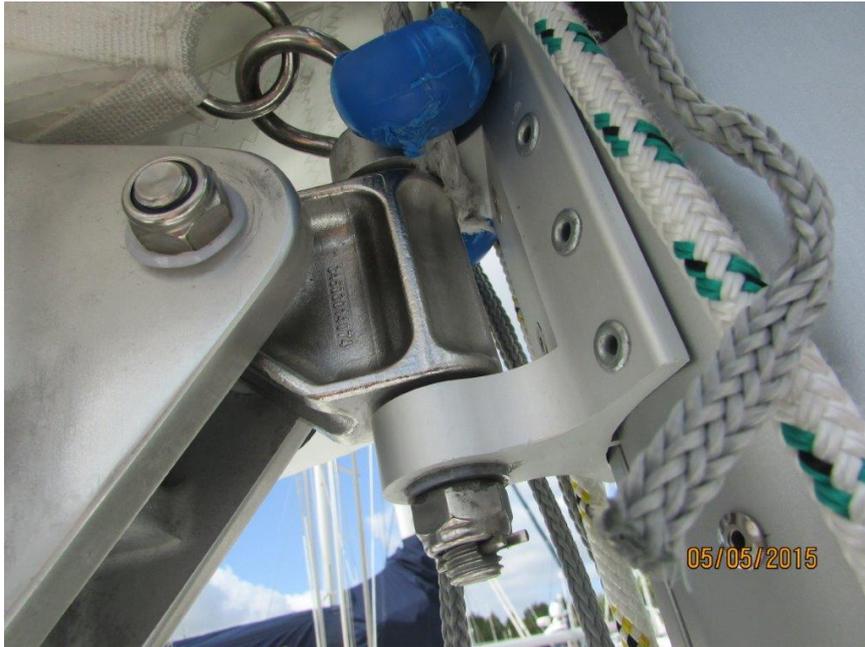
Skippers are reminded that should it be necessary to put in reef 3 then the 'tack' shackles on both sides of the mainsail should be clipped to the rings on both sides of the sail. Clipping down on one side only puts too much strain on the rig securing the shackles and the blue plastic retaining collar. Already the collar on the starboard side has become badly gouged (see below).
