Civil Service Sailing Association - Channel Sailing

SKIPPER'S NOTES – Yacht Sea Essay of Hamble

Newsletter No 03/17

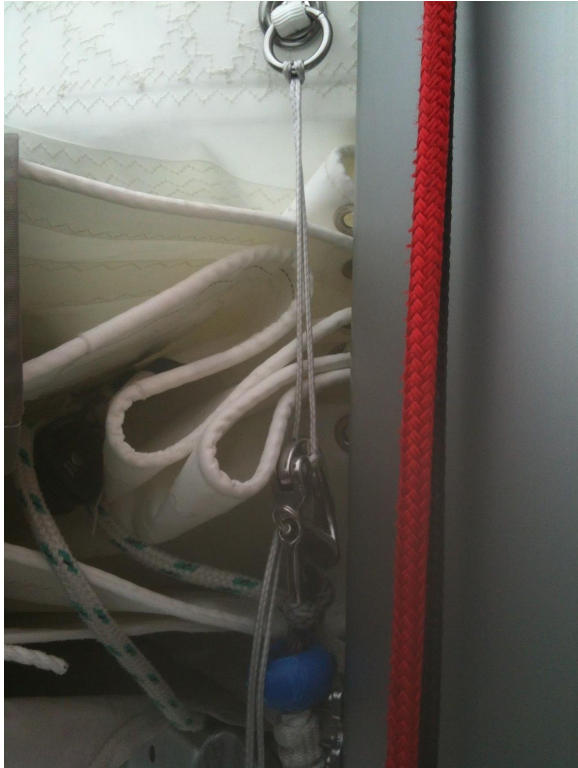
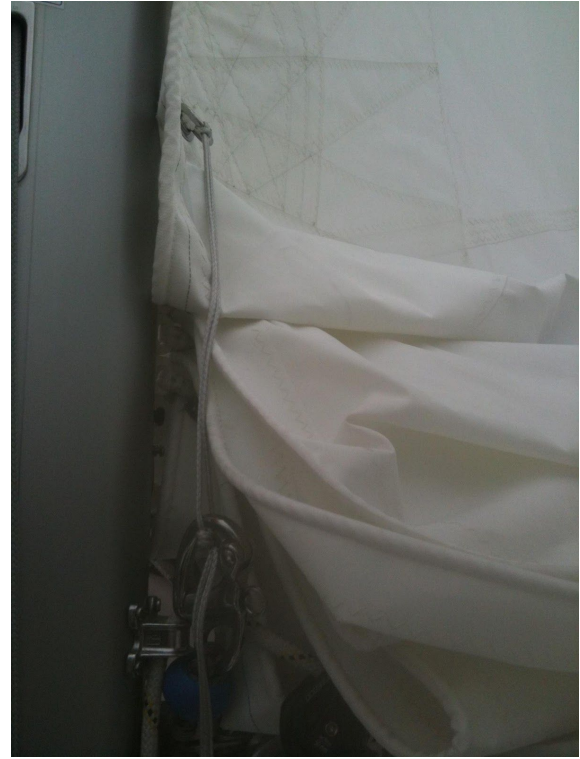
Reef 3 Tack Starboard and Port views

mainsail, the existing reef 3 tack arrangement does not work. We have modified it accordingly. There are now loops of 4mm Dynema (which has a 1 tonne breaking strain) through the spectacle rings on both side of the mainsail. The reef 3 snap shackles are then simply clipped through the Dynema loops and the halyard tensioned as normal. The photographs below show the new loops on each side of the sail and how they are rigged.

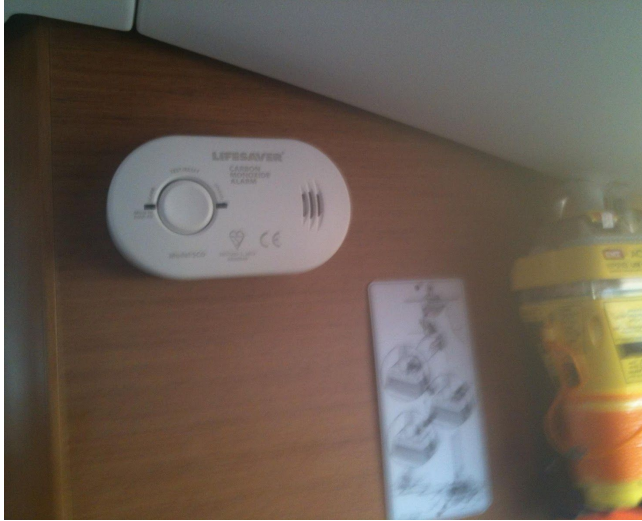
CO Alarm Main Cabin

New Carbon monoxide alarms have been fitted in the main cabin on the bulkhead above and behind the chart table next to the EPIRB and above the cabin door on the inside of the stbd aft cabin. The gas safety inspector refused to re certify our existing CO alarm as it was situated too low down in the main cabin. It proved very difficult to re locate it hence an additional battery powered alarm was fitted in a higher place. The sources of CO on the boat are engine exhaust fumes, a malfunctioning diesel cabin heater and the galley. The diesel cabin heater, engine and the galley are all close to the stbd aft cabin so an additional alarm has been installed there. The pictures below show the locations.
