Civil Service Sailing Association - Channel Sailing Division

SKIPPERS NOTES – Yacht Sea Essay of Hamble

Newsletter No 01/19

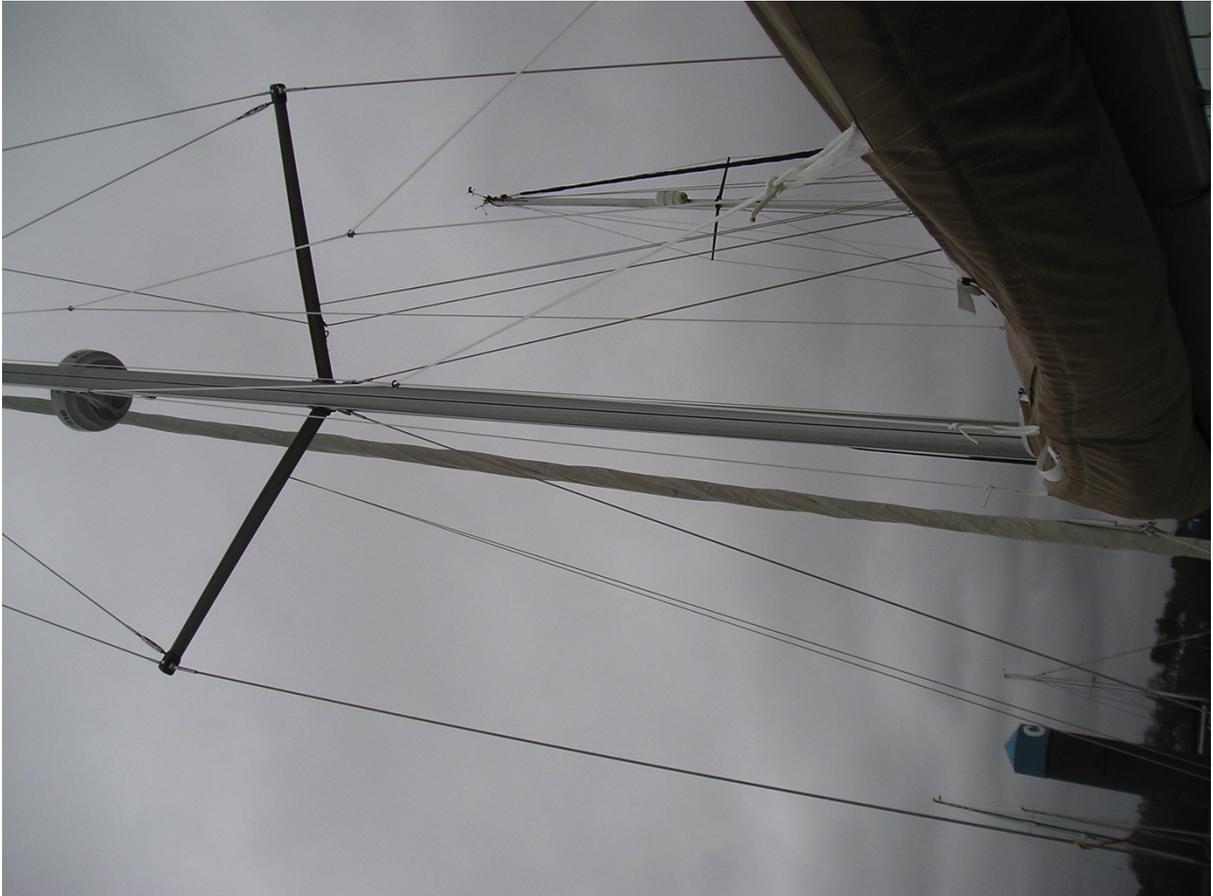
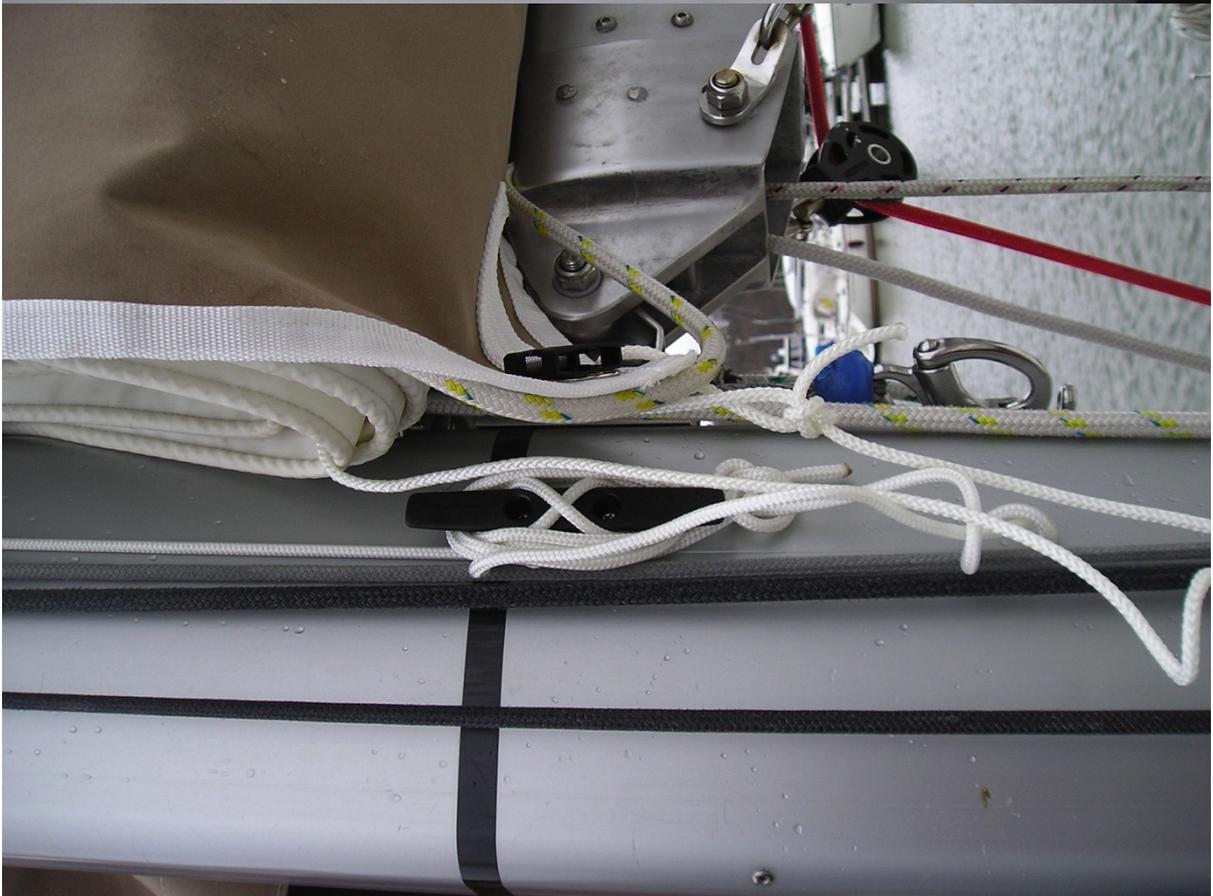
These have been replaced. The new lazy jacks run up to pulley blocks on the mast and then down to cleats on either side of the mast (see photos at end). This is same arrangement as was on the Dufour 405 and is much easier to adjust than the previous Jeanneau arrangement where the lazy jacks were tied to the mast at the top and adjusted on the sail cover itself.

Note that the lazy jacks and sail cover are not designed to support the boom. Skippers should be prepared to adjust the lazy jacks when the boom height is varied and especially when the main sail profile is flattened using the boom vang.
